DOT/FAA/CT-94/56

# Characterization of Corrosion and Development of a Breadboard Model of a D Sight Aircraft Inspection System: Phase I

August 1994

Final Report

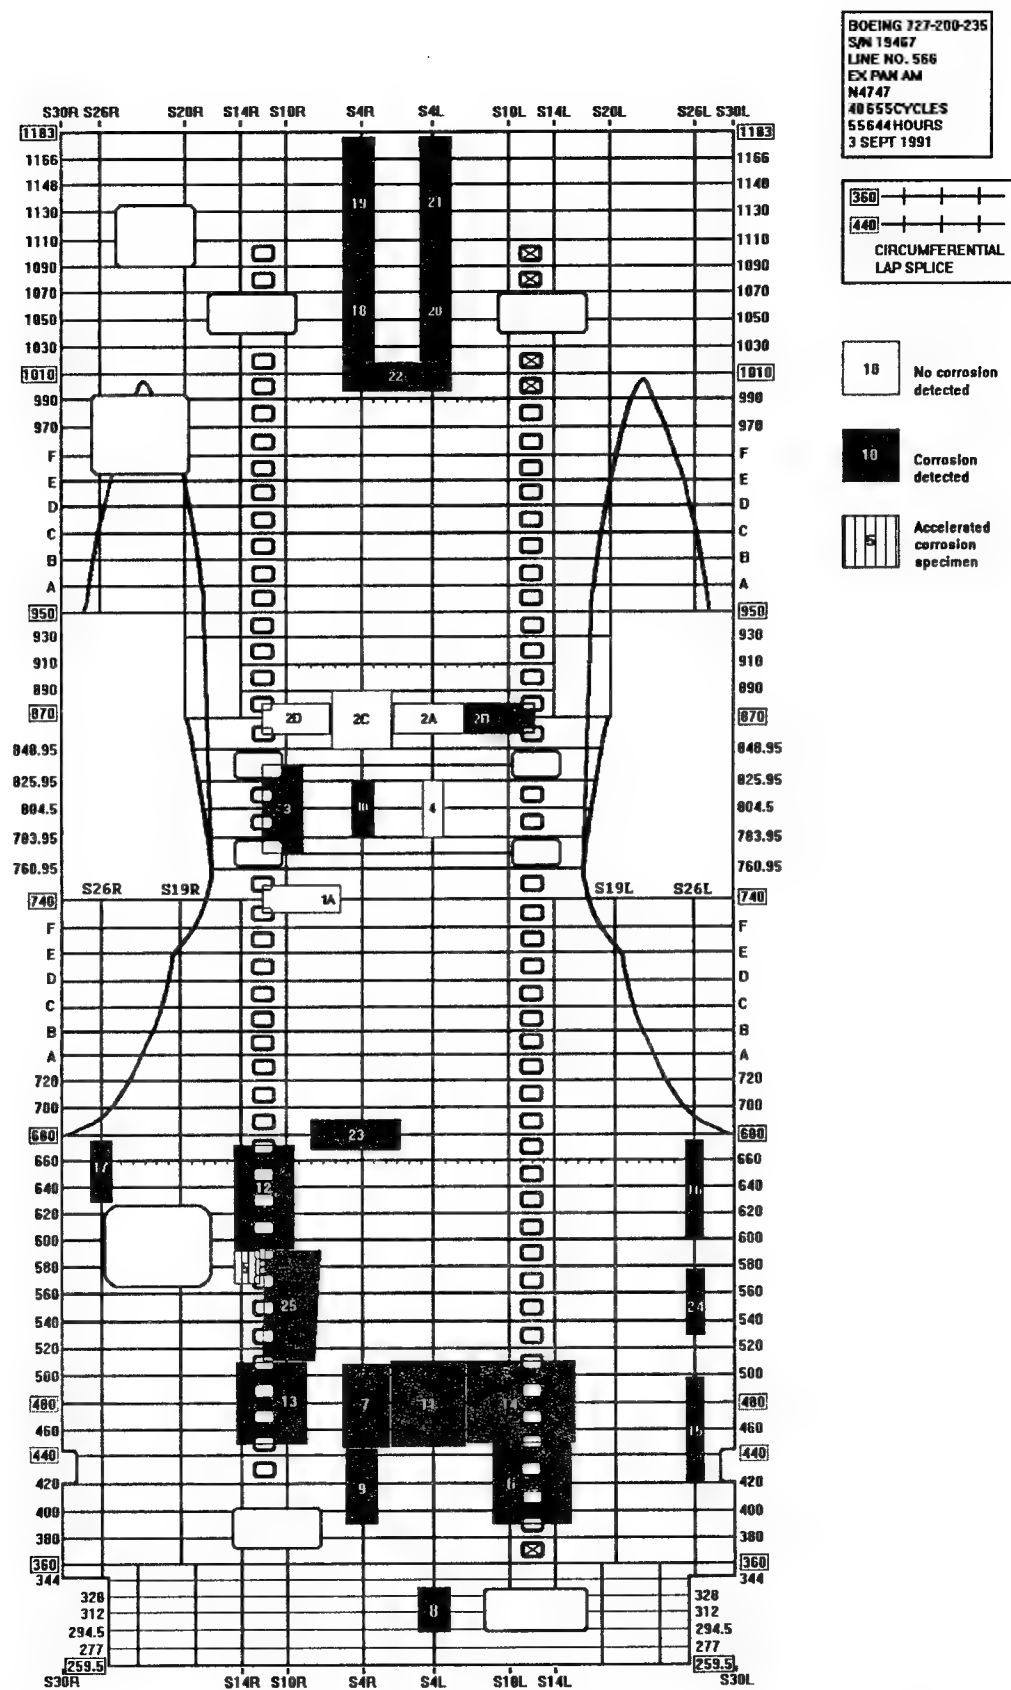
Specimen Number	Image Number	D Sight Image Comment and (construction of the joint)
16	0	6 rivets middle row from edge
	1-2	
	3	6 rivets top row
17	0-1	pillowing 4 rows top to bottom
	2-4	heavy pillowing
18	0-3	heavy pillowing
19	0-1	pillowing top to bottom 20 rivets from edge
	2-3	
	4	middle row 6 rivets
20	0-1	pillowing 8 rivets top and middle row
	2-4	
	5	3 rivets top and middle row mark 6-8
	6	
	7-8	pillowing 11 rivets top and middle mainly
21	0	2 rivets top row mark 8-10
	1	
	2	3 rivets middle row mark 6-8
	3-6	
	7	slight pillowing
22	0-1	(circumferential)
	2-3	pillowing top row
	4	
23	0	pillowing bottom rows (circumferential)
	1	
	2-4	pillowing bottom rows
	5-8	
24		(repaired, corrosion?)
25	0-8	heavy corrosion

Figure 5.7 B727-N4747 specimens. Results of D Sight inspection for corrosion.

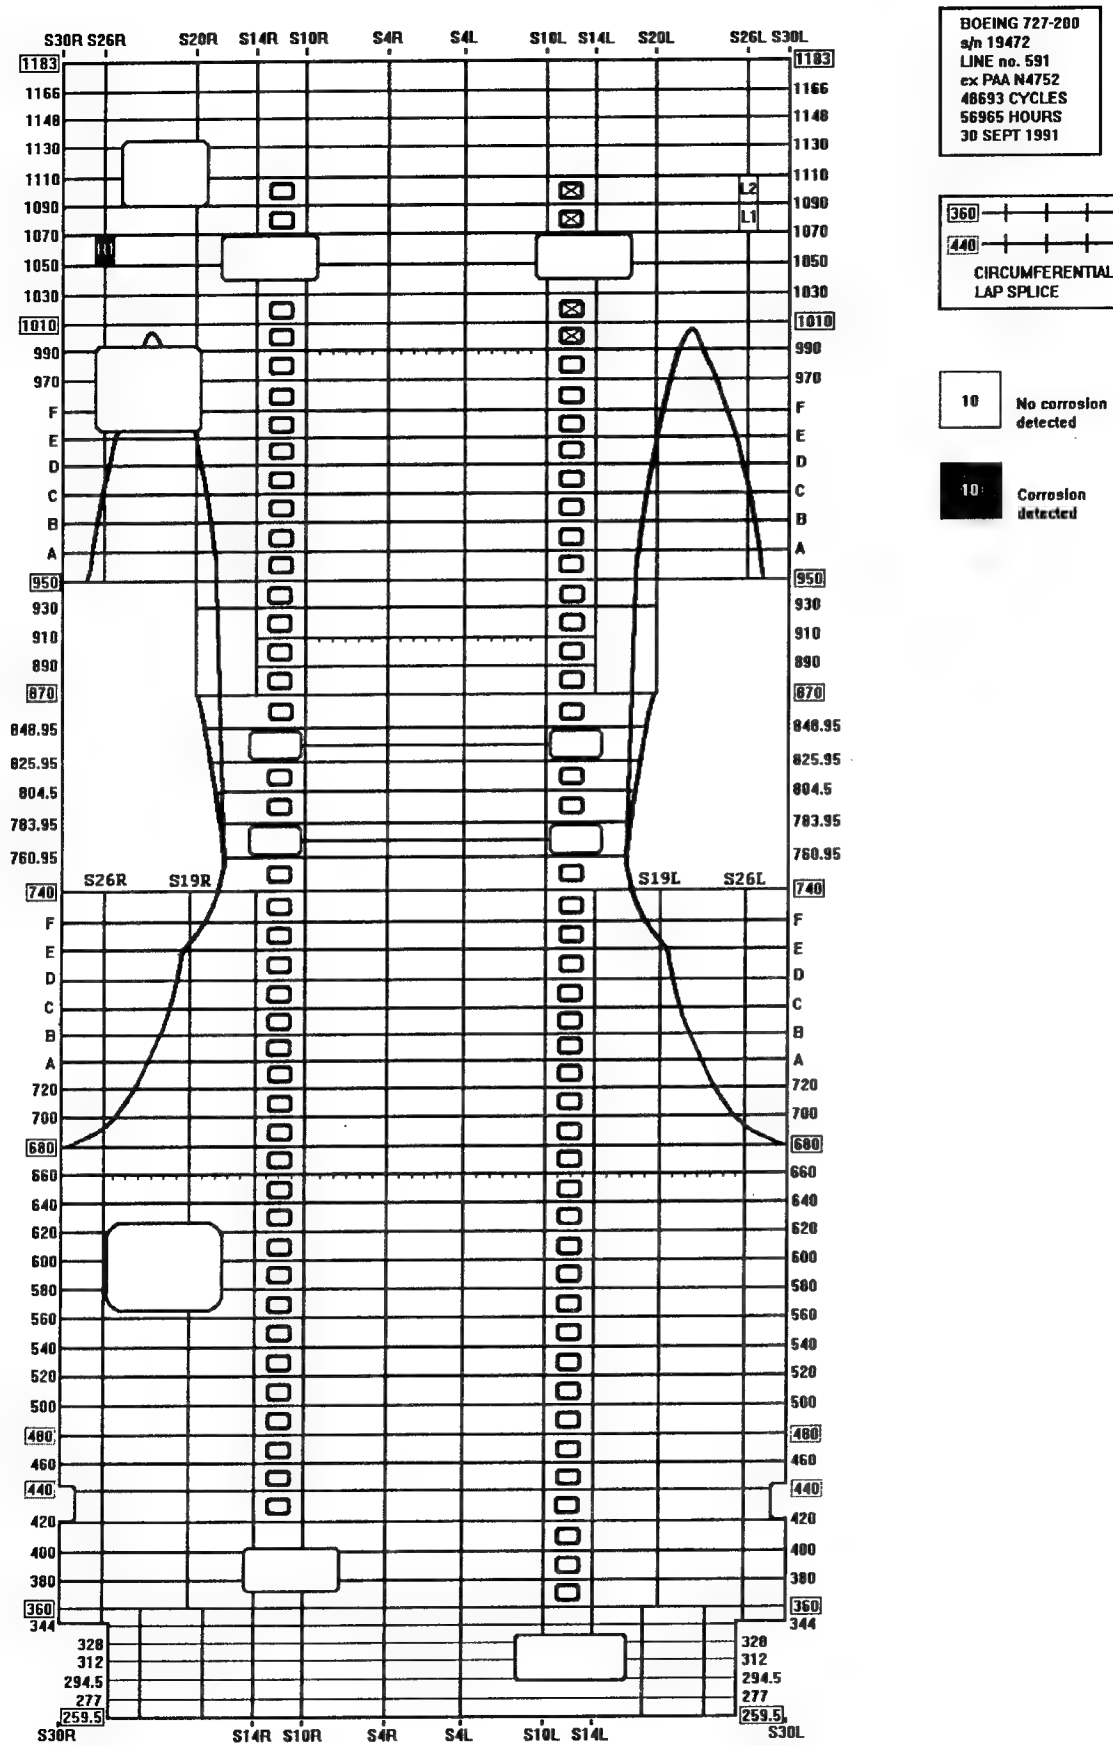
Specimen Number	Image Number	D Sight Image Comment and (construction of the joint)
L1		
L2		
R1		middle row slight pillowing

Figure 5.9 B727-N4752 specimens. Results of D Sight inspection for corrosion.

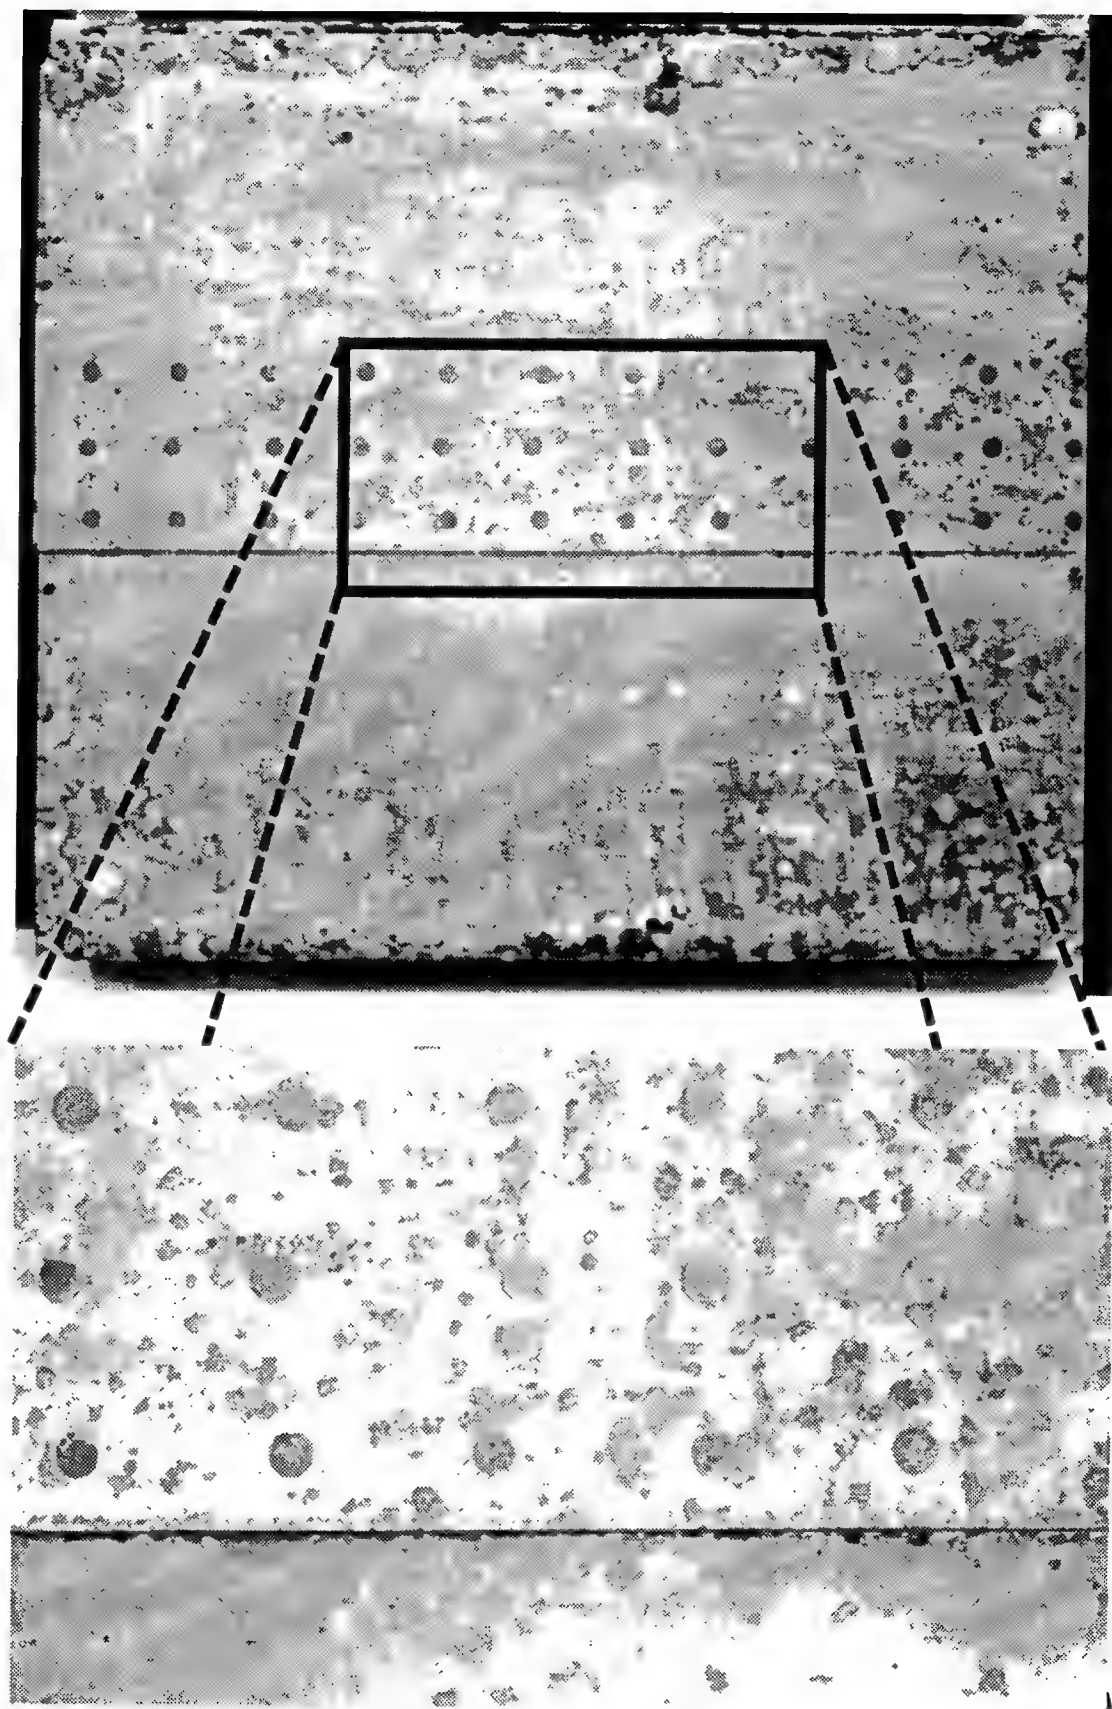
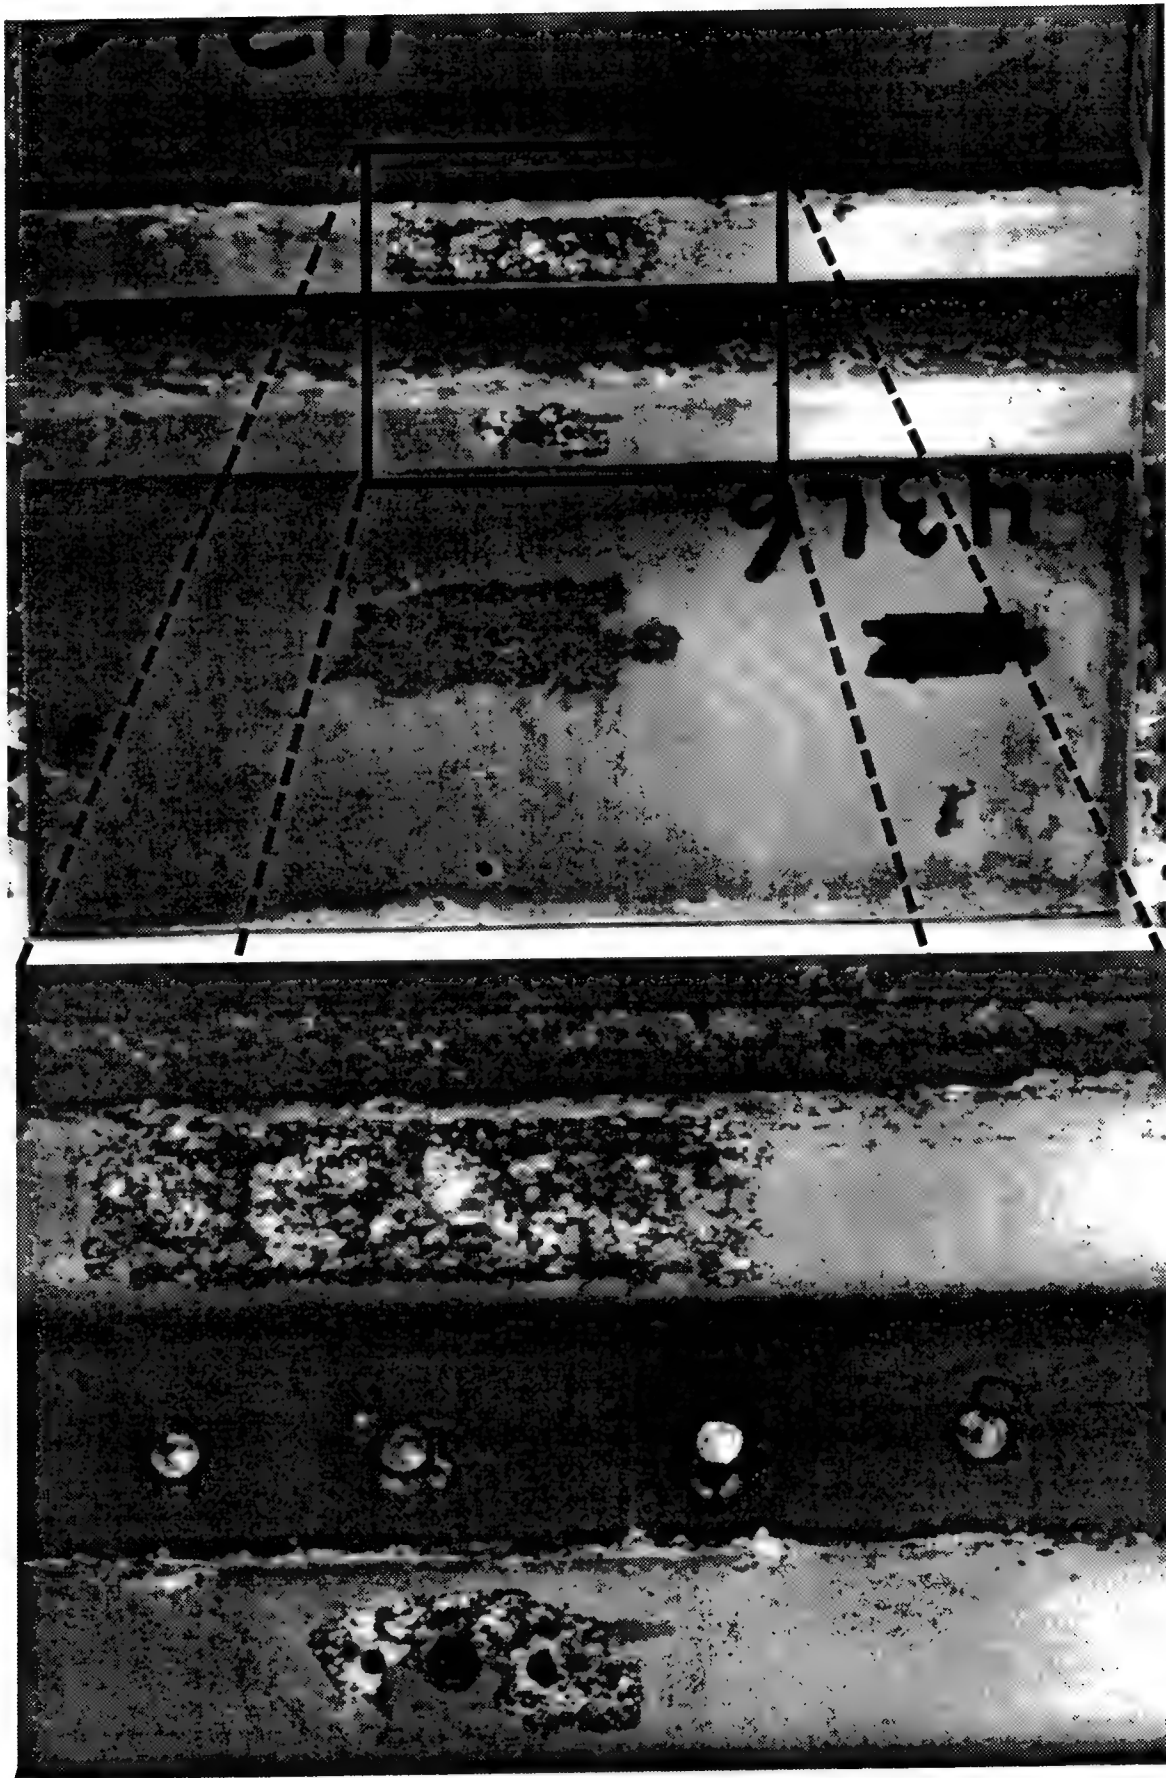
The results of the radiography inspection are illustrated in Figs.6.1 to 6.6. The ambient view photographs of the exterior and interior surfaces of the two lap joint specimens DC-9 Specimen 21A and Boeing 727 Specimen 43L6, taken after exposure to salt spray for a total of 1104 hours, are shown in Figs.6.1, 6.2 and Figs.6.4, 6.5 respectively, along with close-up views of the most heavily corroded sections. Figs. 6.3 and 6.6 are x-ray images of the DC-9-21A and B727-43L6 specimens respectively recorded at the end of the test. Significant amounts of corrosion are obvious in the ambient views of the interior and exterior surfaces of both specimens. Virtually no corrosion is identified in the x-ray of the DC-9 specimen (Fig.6.3). The x-ray of the Boeing 727 specimen (Fig.6.6) however, exhibits several dark areas which are indicative of corrosion within the lap joint.

**Figure 6.1** B727 specimen 43L6 ambient exterior view and close up.

**Figure 6.2 B727 specimen 43L6 ambient view and close up - rear surface.**

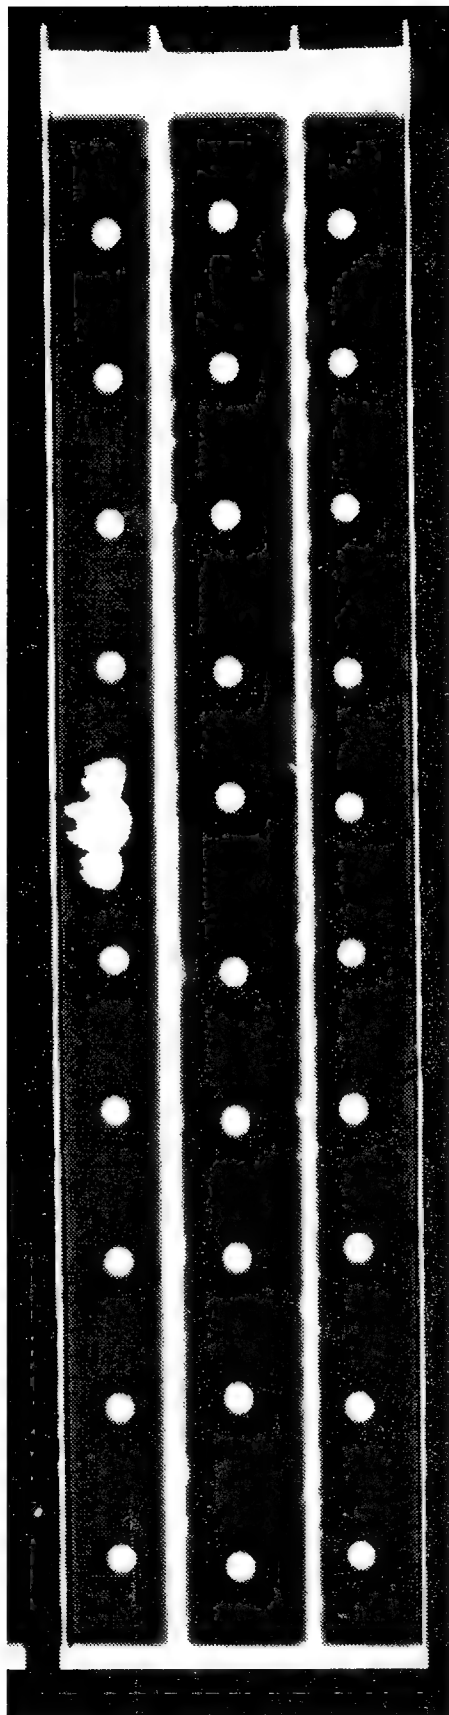
**Figure 6.3** B727 specimen 43L6 radiograph - 1104 hours exposure to accelerated corrosion.

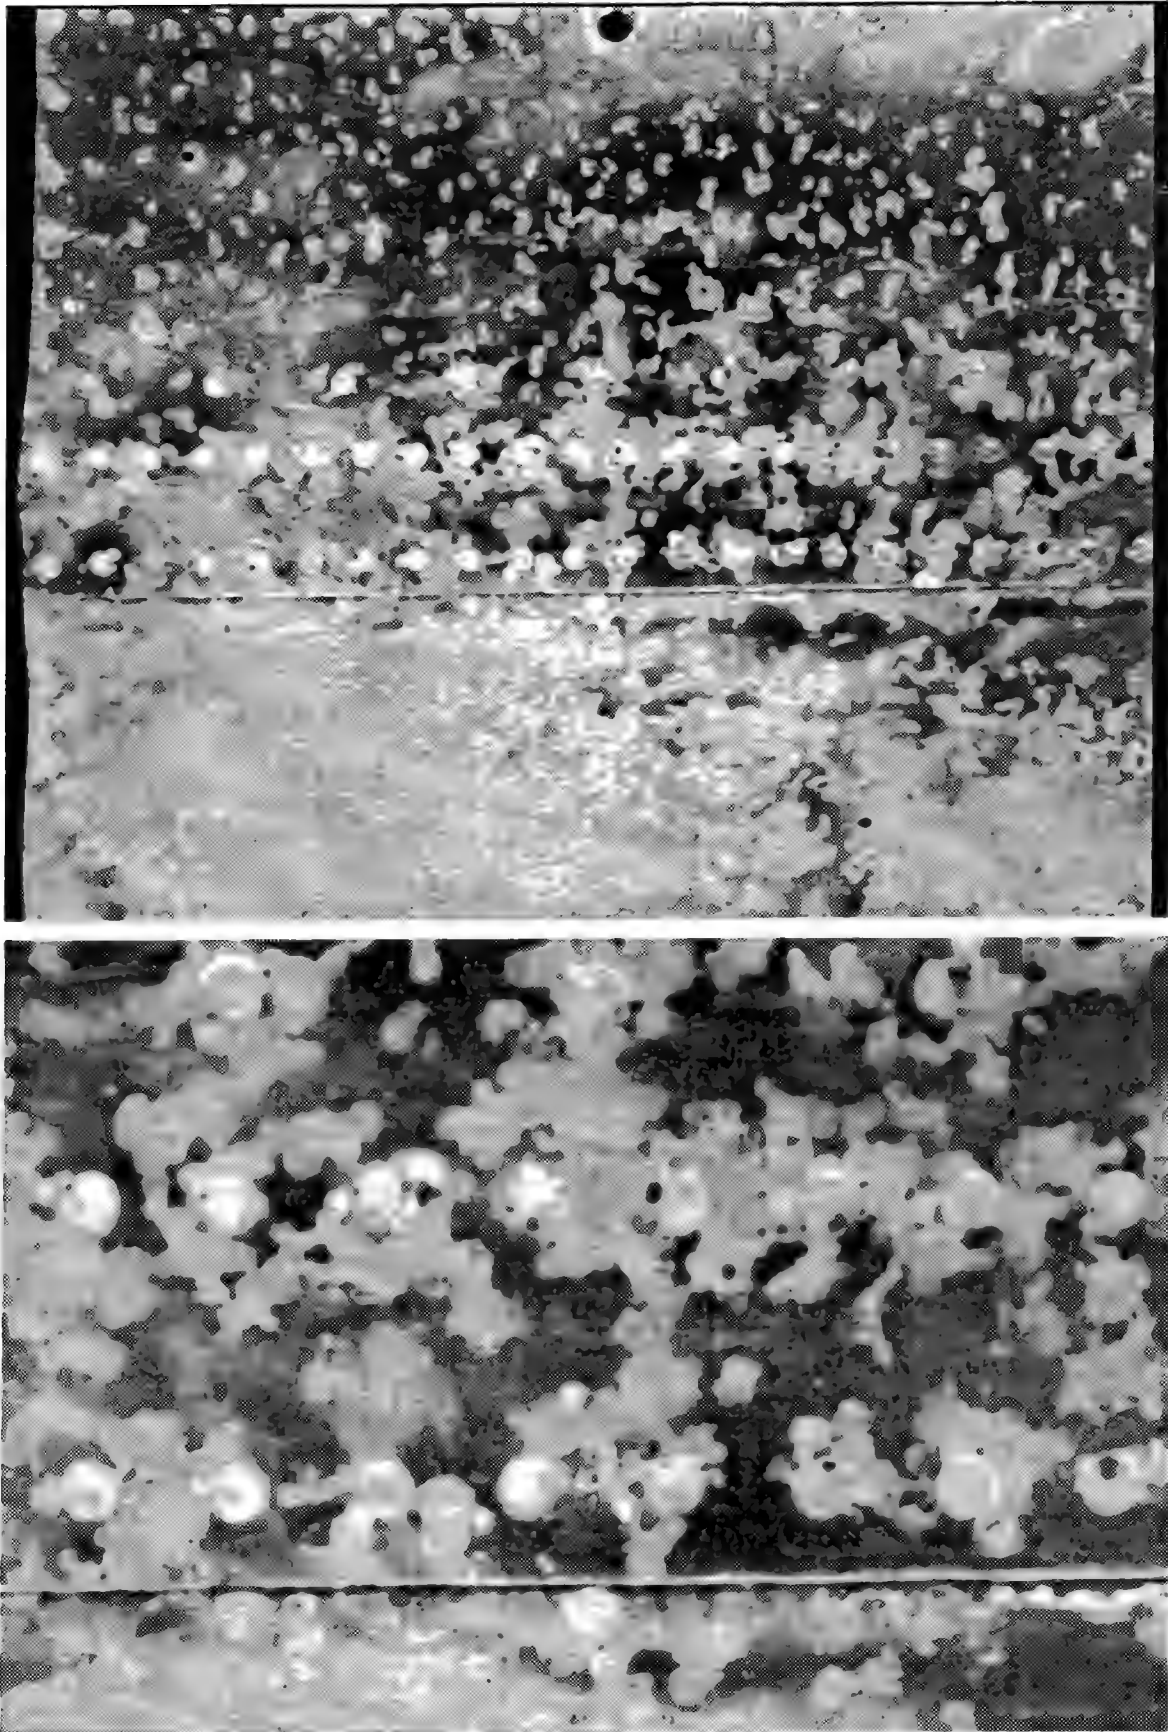
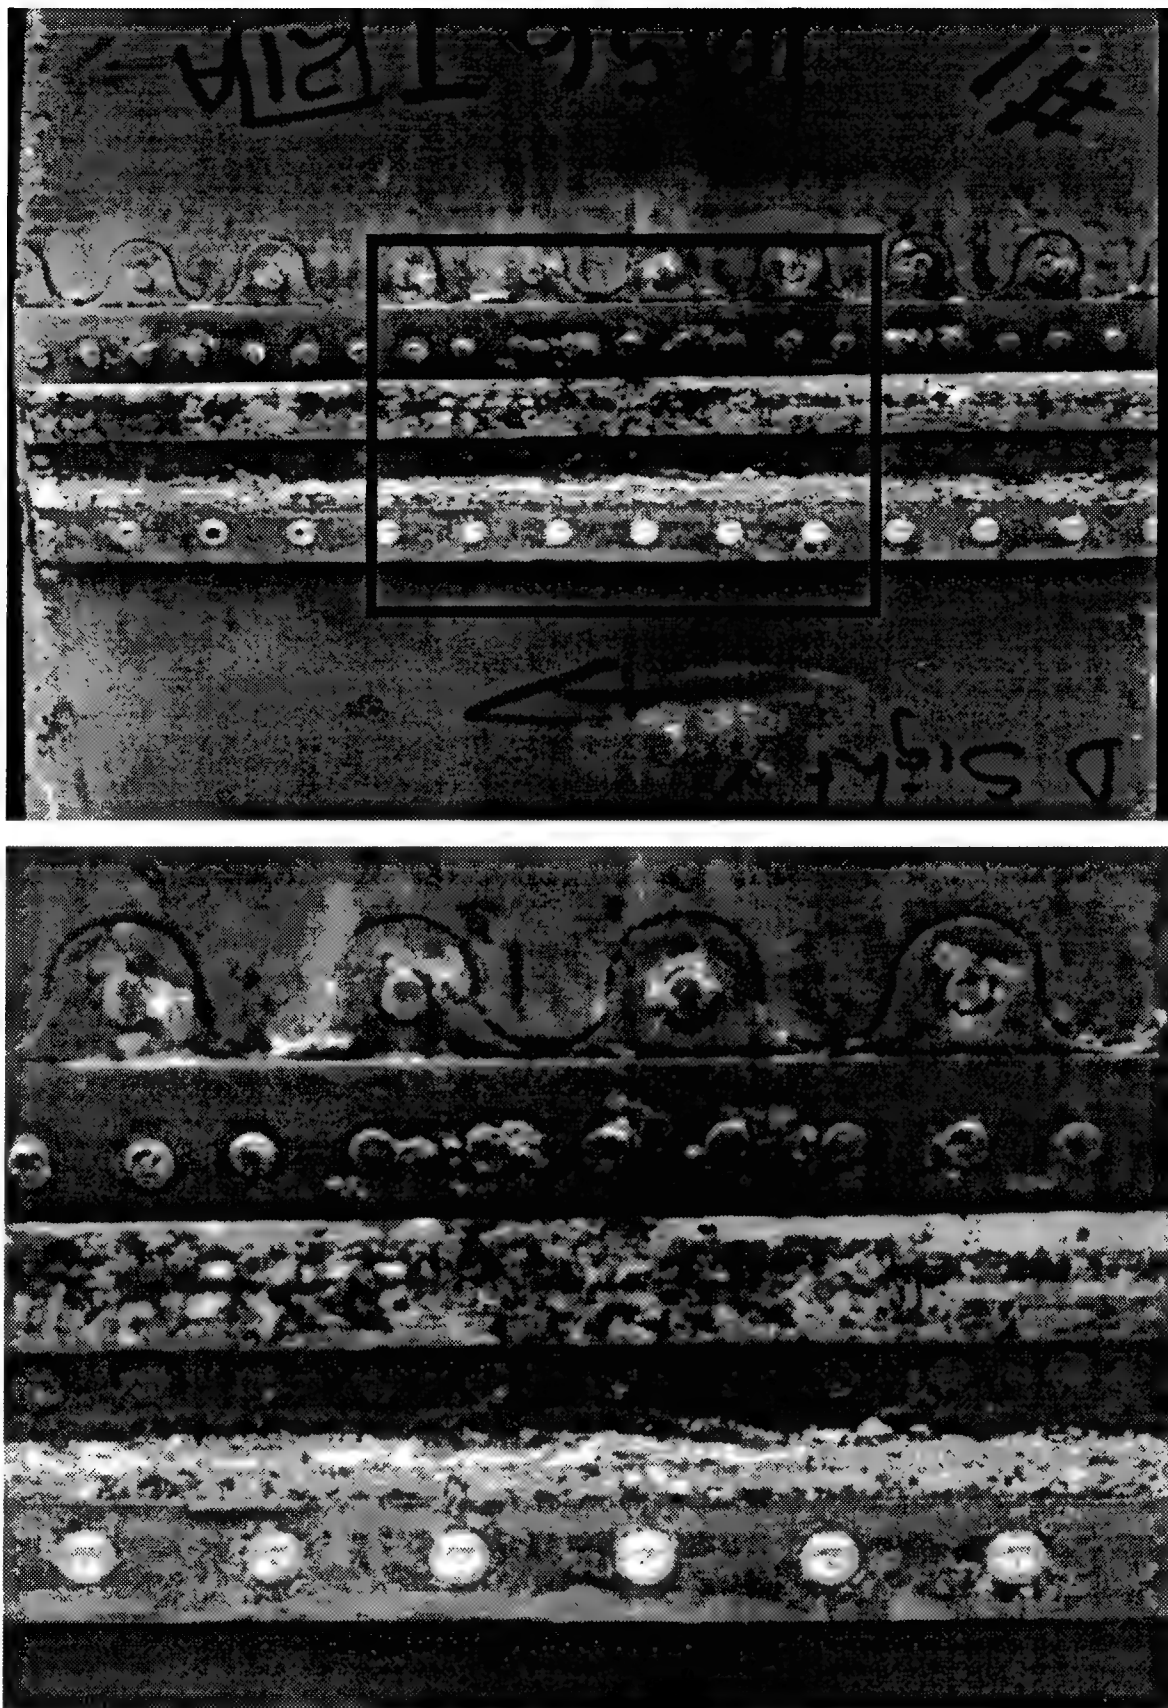
**Figure 6.4** DC-9 Specimen 21A exterior surface and close up view.

**Figure 6.5 DC-9 Specimen 21A inner surface and close up view.**

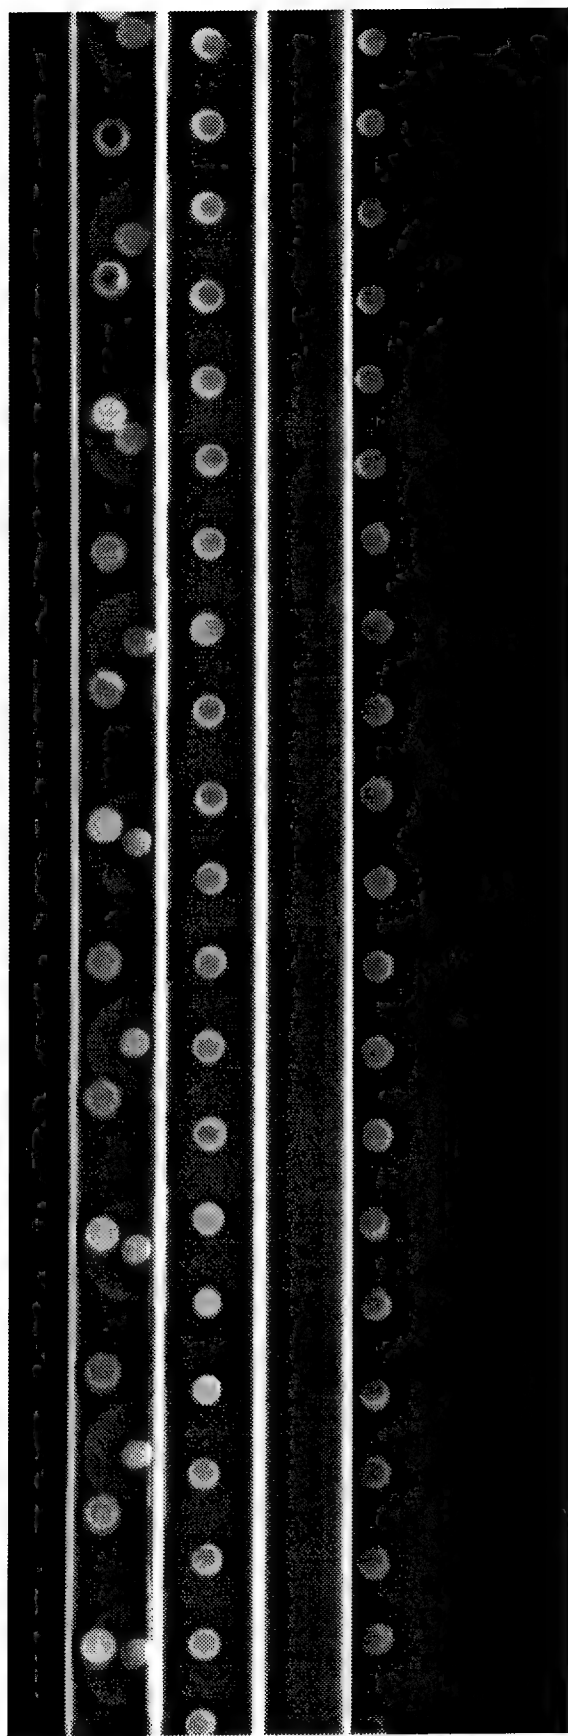
**Figure 6.6 DC-9 Specimen 21A radiograph - 1104 hours exposure to accelerated corrosion.**

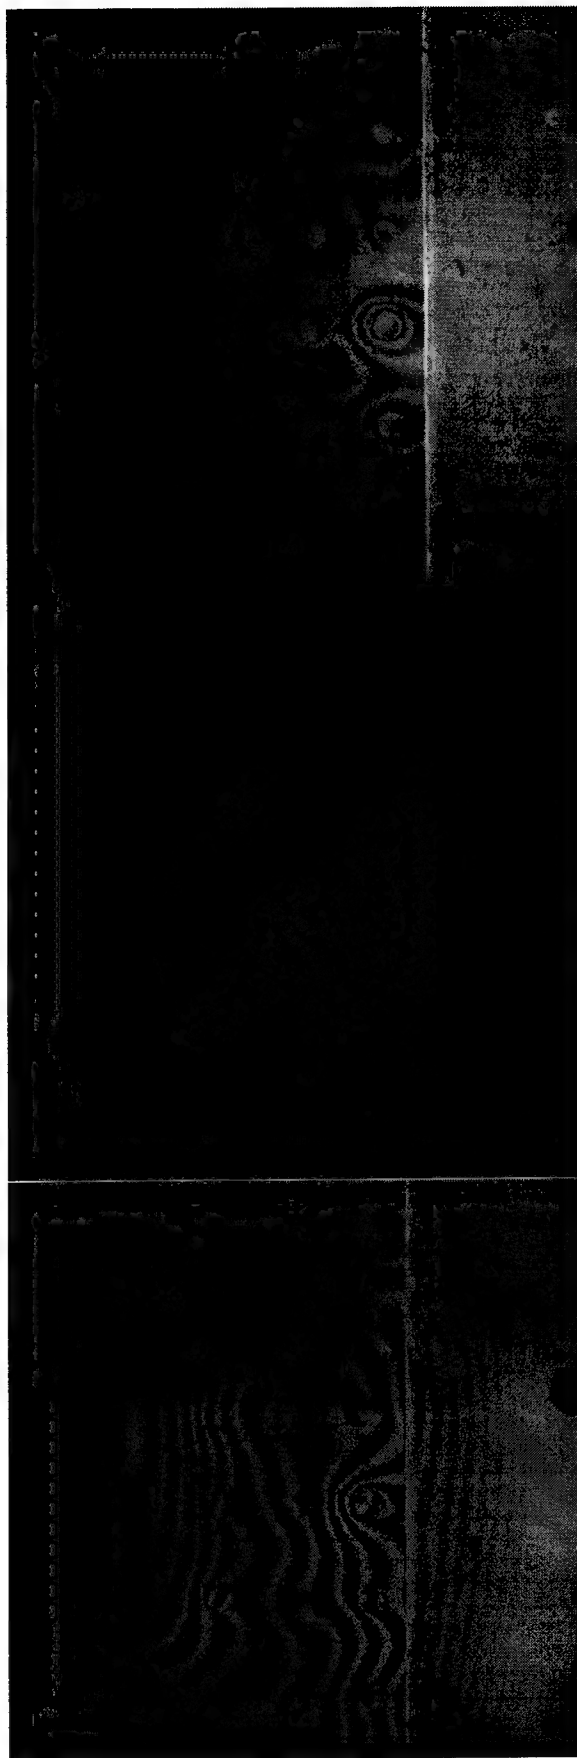
<b>Specimen Number</b>	<b>Figure Number</b>	<b>Maximum measured deflection</b>	<b>Remarks</b>
51L2	Fig.6.7	0.005"	Corrosion in the bottom row
43L6	Fig.6.8	0.007"	Corrosion evident
43L7R	Fig.6.9	0.007"	Corrosion throughout, max. in top row
46L3A	Fig.6.10	0.003"-0.004"	Corrosion less evident
46L3C	Fig.6.11	0.007"	Corrosion evident
46L3E	Fig.6.12	0.013"	Extensive corrosion, even across rows
46L4A	Fig.6.13	0.005"	Corrosion less evident
46L4C	Fig.6.14	0.010"	Corrosion very evident
56T21A	Fig.6.15	0.005"	Value indicates deflection of free lip

Figure 6.8 Shadow moiré inspection results at various corrosion exposure times.

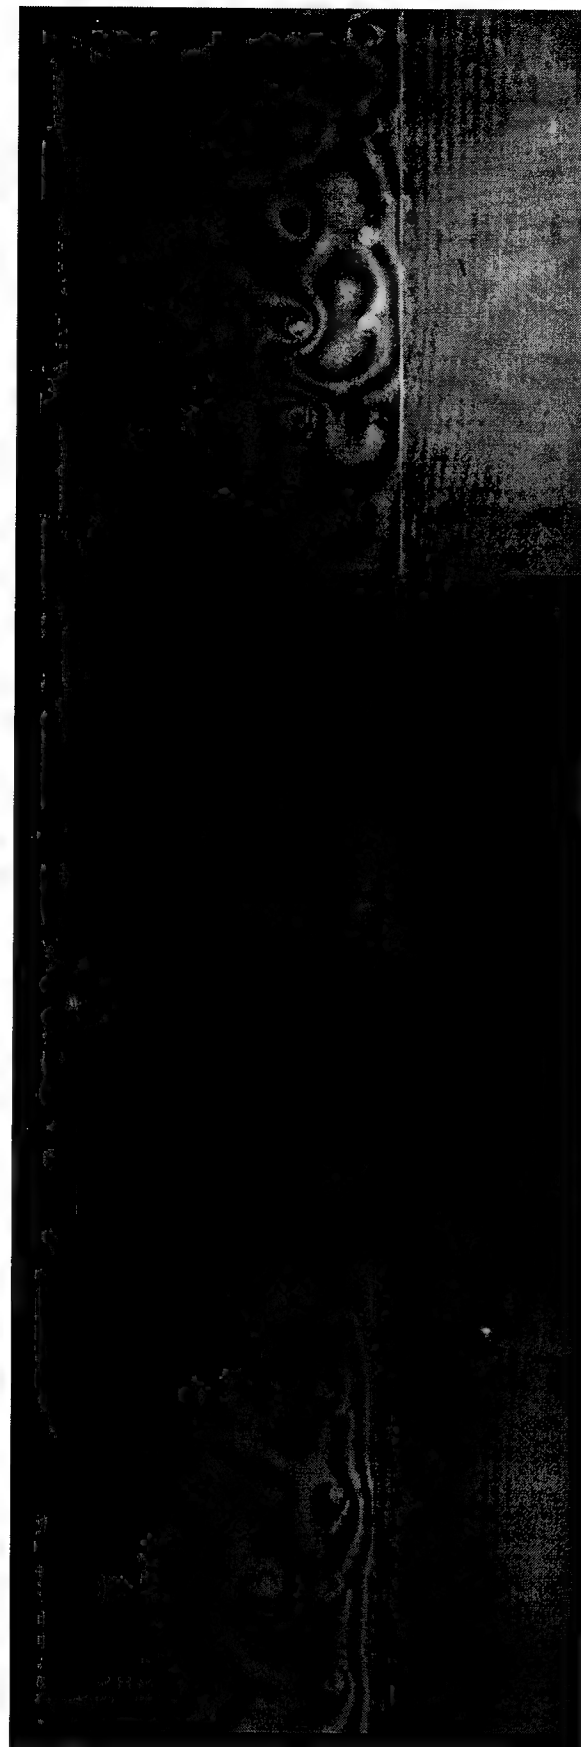
**Figure 6.9** Shadow moiré inspection results at various corrosion exposure times.

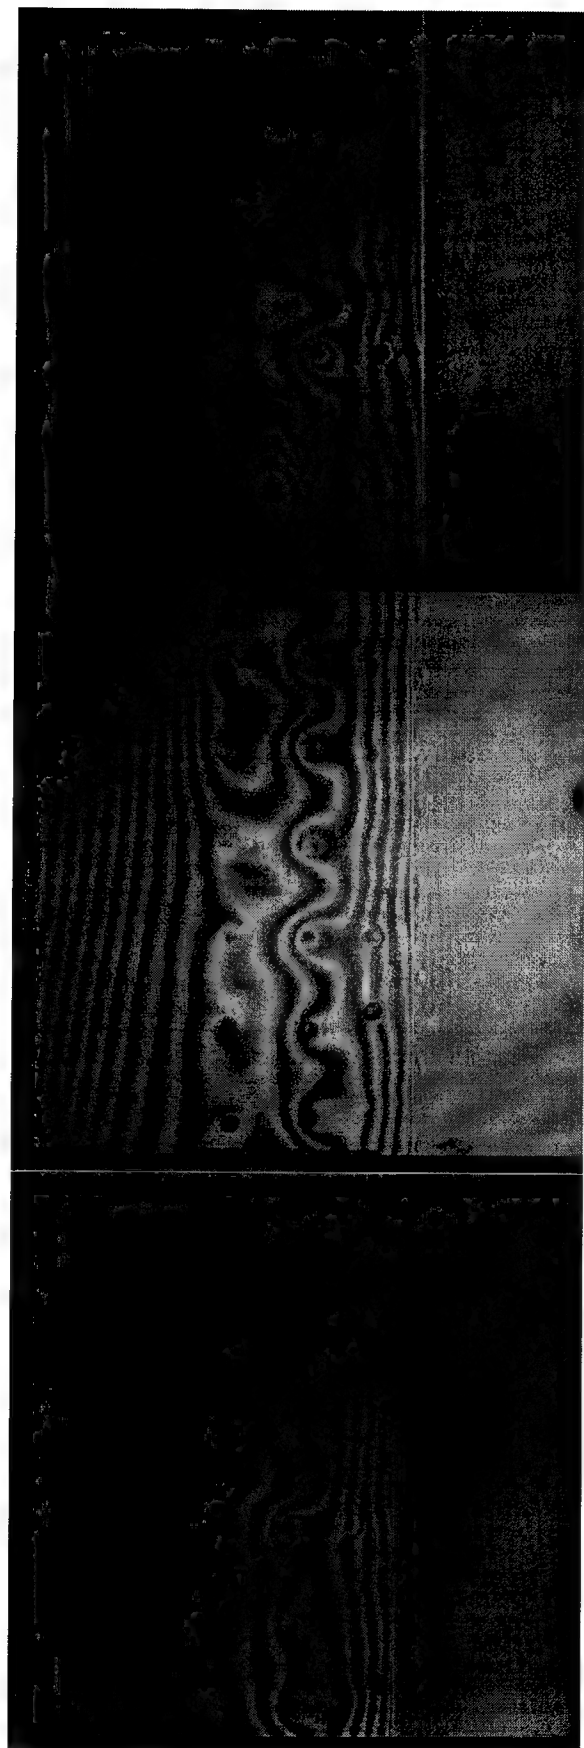
**Figure 6.11** Shadow moiré inspection results at various corrosion exposure times.

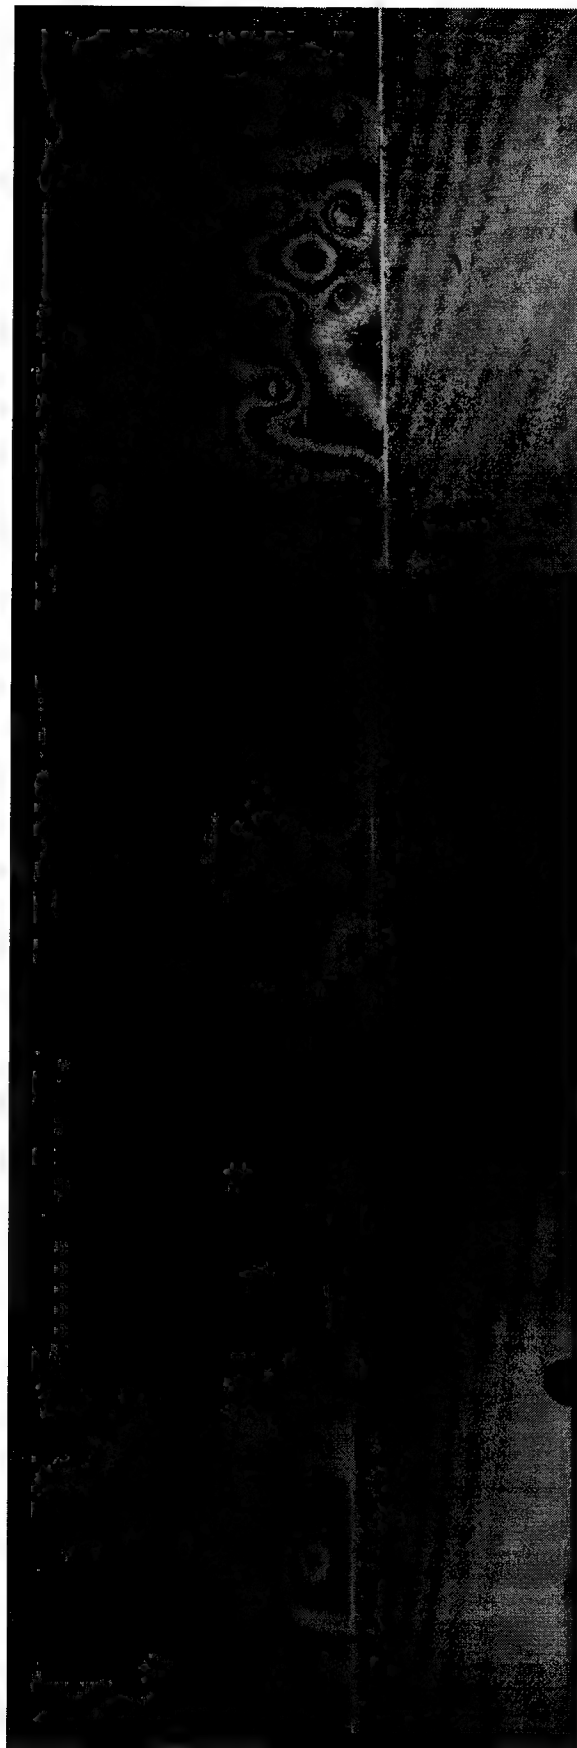
**Figure 6.13** Shadow moiré inspection results at various corrosion exposure times.

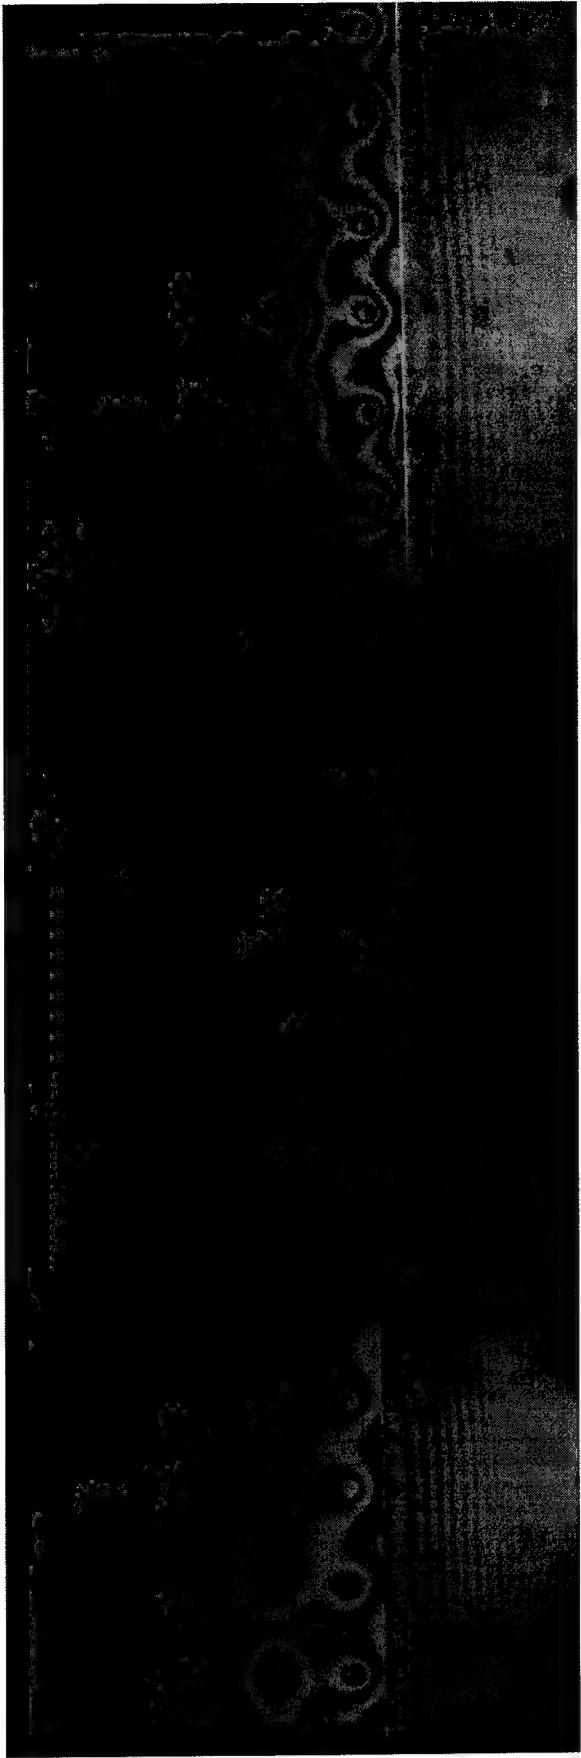
Figure 6.14 Shadow moiré inspection results at various corrosion exposure times.

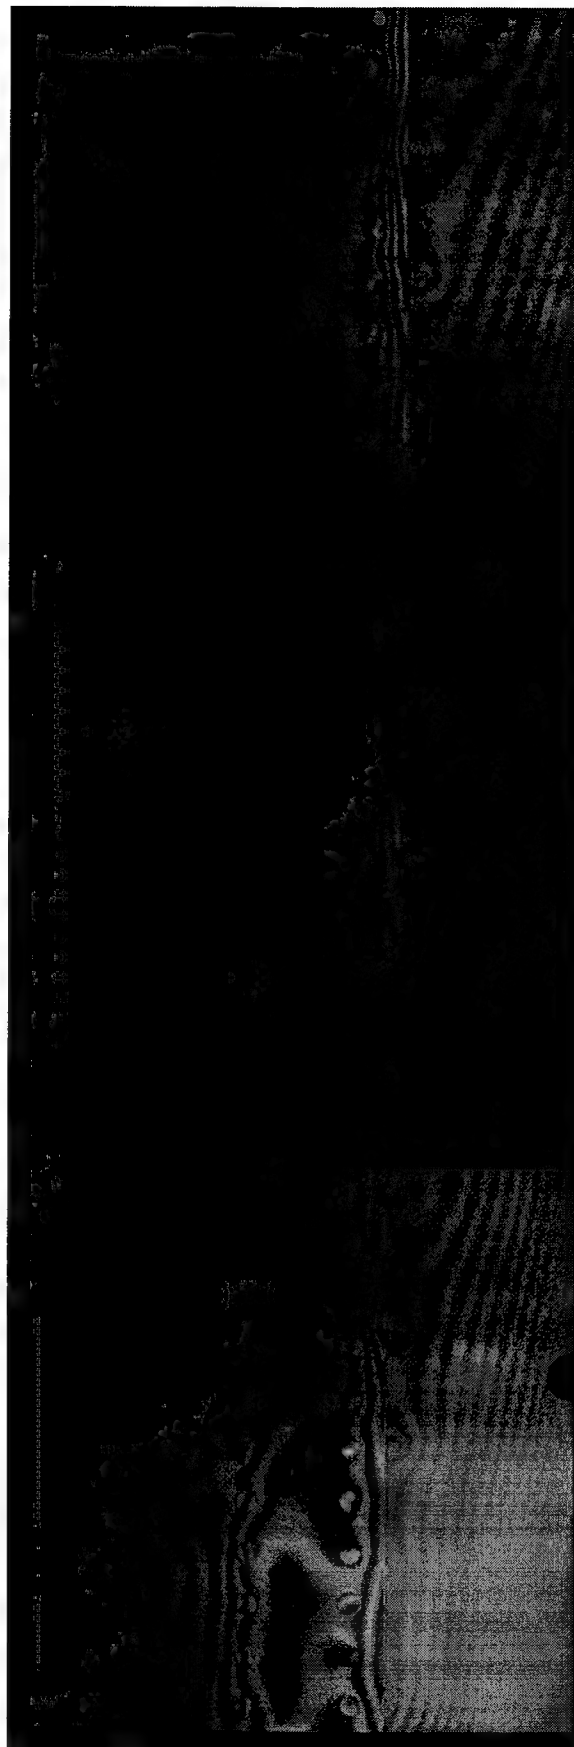
**Figure 6.15** Shadow moiré inspection results at various corrosion exposure times.

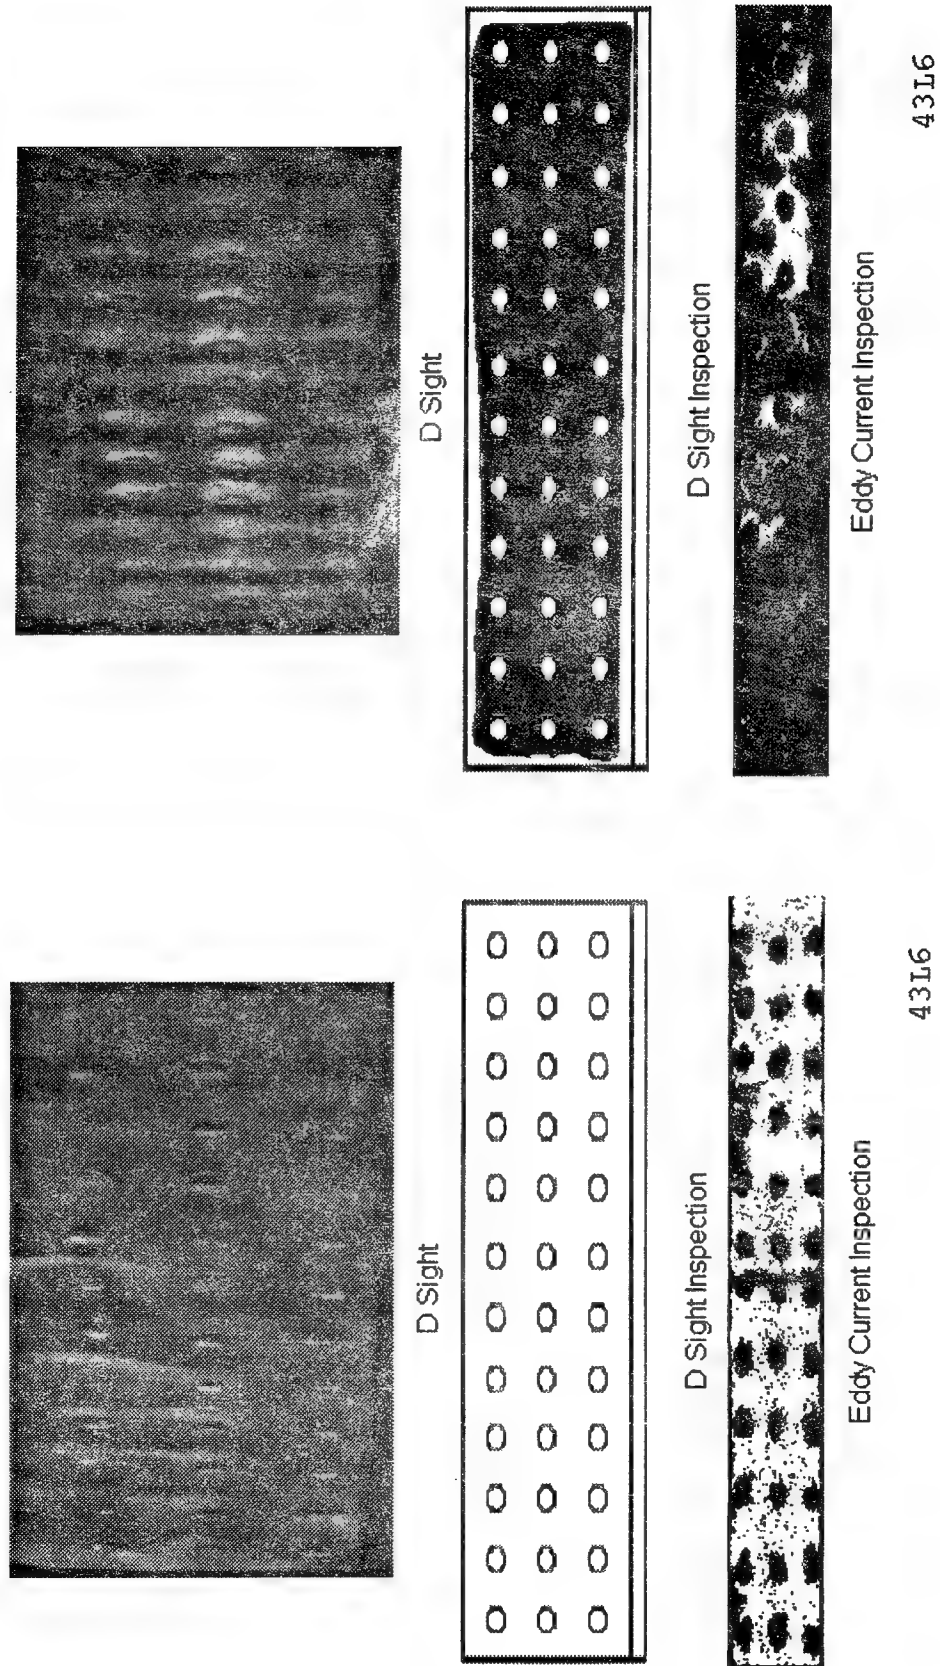
Figure 7.1 Specimen 43L6 pre- and post-corrosion inspection results. D Sight images, D Sight and Eddy Current corrosion maps.
